**ADULT FISHWAY INSPECTIONS
ON THE COLUMBIA AND SNAKE RIVERS**

2005 ANNUAL REPORT

**FISH PASSAGE CENTER
1827 NE 44th Ave.
Portland, OR 97213**

March 2006

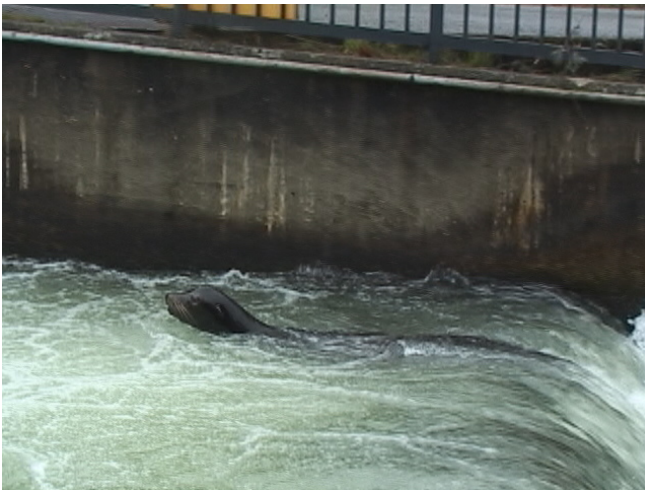
Figure 2a. An adult sea lion swimming upstream in the Bonneville Dam fish ladder in late March 2005.

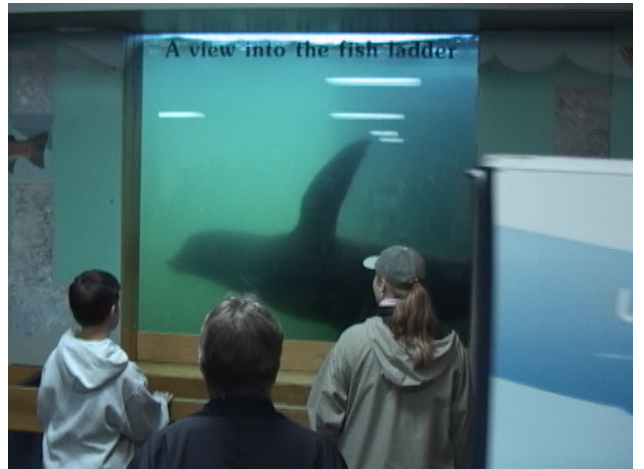
Figure 2b. Large sea lion upstream of counting window during this 2005 season.

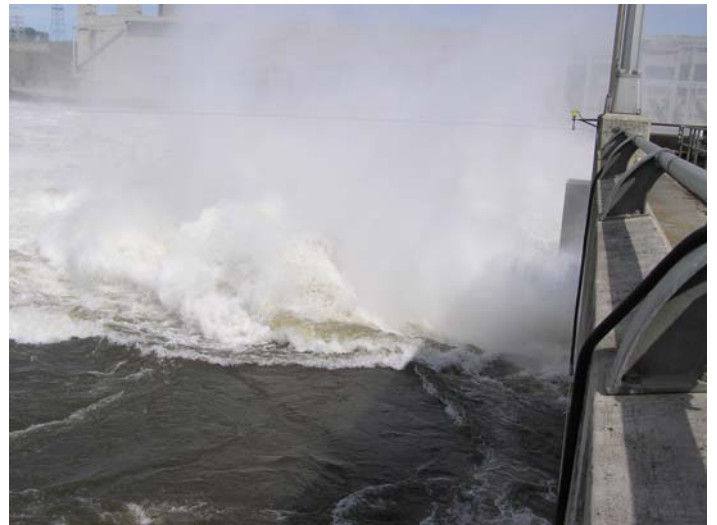
- **One of the major problems, potentially visual rather than fish passage is the huge side eddy that forms immediately downstream from the NPEs when spill at some level is present. It would appear to obliterate passage through that entrance. If that is the case, then more emphasis should be placed on assuring that the SFEWs be given higher priority for being in criteria (weir depths were lacking throughout the 2005 season). Secondly, if the Project cannot maintain criteria on the South fishway then it should shut down the floating orifice gates and use that water to improve passage conditions at the South entrance.**

Figure 5b. Spring spill conditions will affect fish Passage at the NPEs.

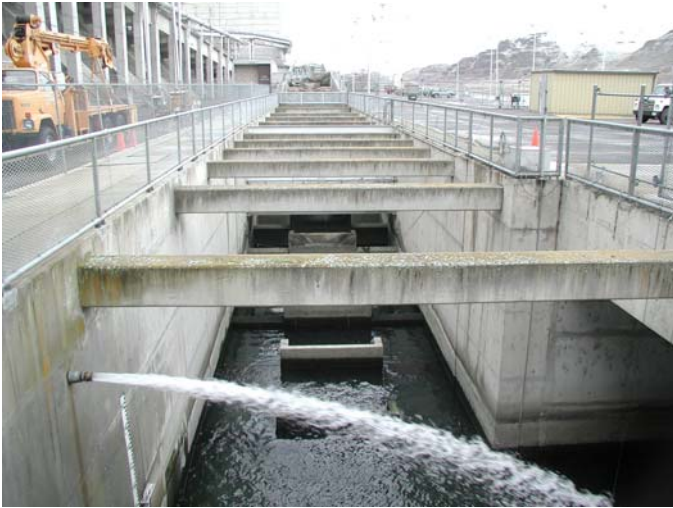
Figure 6a. The 1st fish ladder weirs above the junction pool may be modified similar to the Lower Granite planned modifications that will be installed this winter, 2006. This modification should reduce fallout rates from the fishway, and, and in the long run reduce time to pass a facility and reduce mortality.

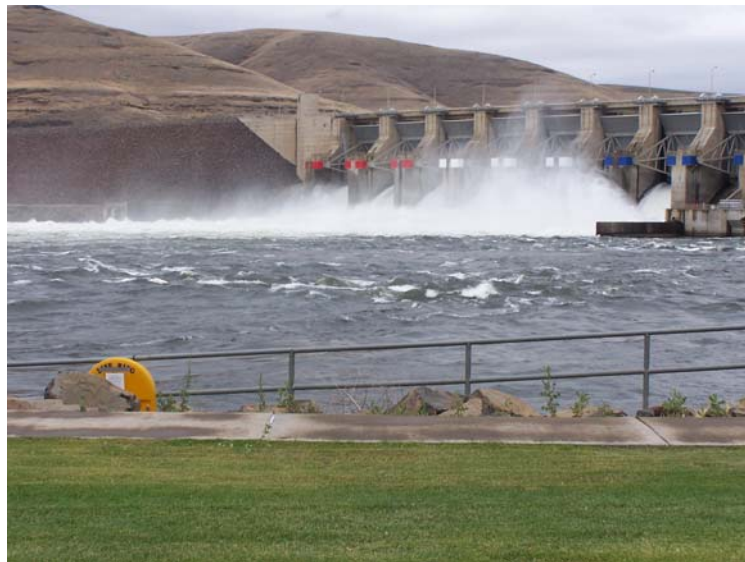
- Summertime spill in the Snake River at Little Goose Dam resulted in near impassable conditions for adult salmon for about a 10-day period until the spill patterns were adjusted and spill reduced to about 30% of flow during daytime hours. The ODFW biologist checked the fishways on several occasions to assure that the facilities were operating within criteria. They were, however, large eddies were prevalent across the face of the powerhouse and basically rendered the entrances impassable.

- **The Judge-ordered spill for the Snake River slowed passage of summer Chinook and potentially to a lesser extent, steelhead at Little Goose Dam. Until spill volume was reduced to 30% of the daytime flow volume did adult fish begin to find entrance gates and pass the dam in large numbers. Again, this points out the requirements that excessive spill volume and improper spill patterns can totally disrupt and stop a fish run.**

Figure 6c. June 28 spill at Little Goose Dam that slowed or stopped passage of adult salmon for nearly 10 day until daytime spill level was reduced to about 30% of flow.

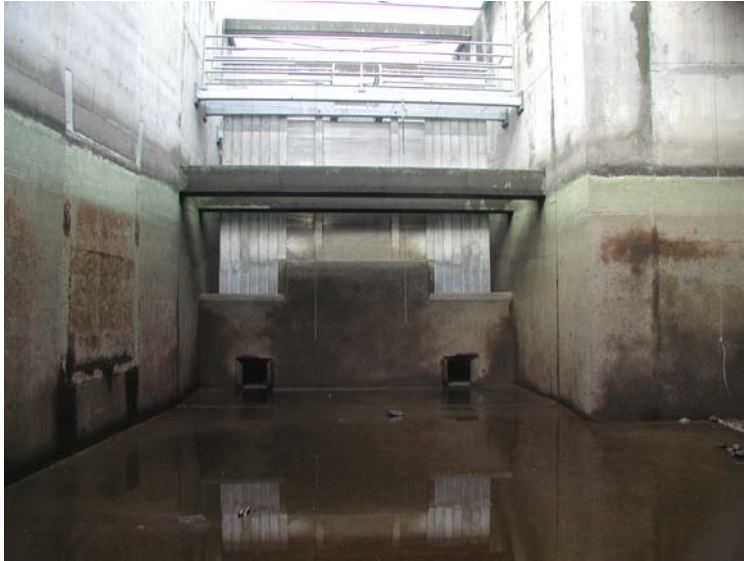
Figure 7a. These photographs show the extended weir crests at the 1st fish ladder weir located above the Junction Pool at the South shore of the Project. This whole area will be modified prior to the 2006 adult fish passage season.

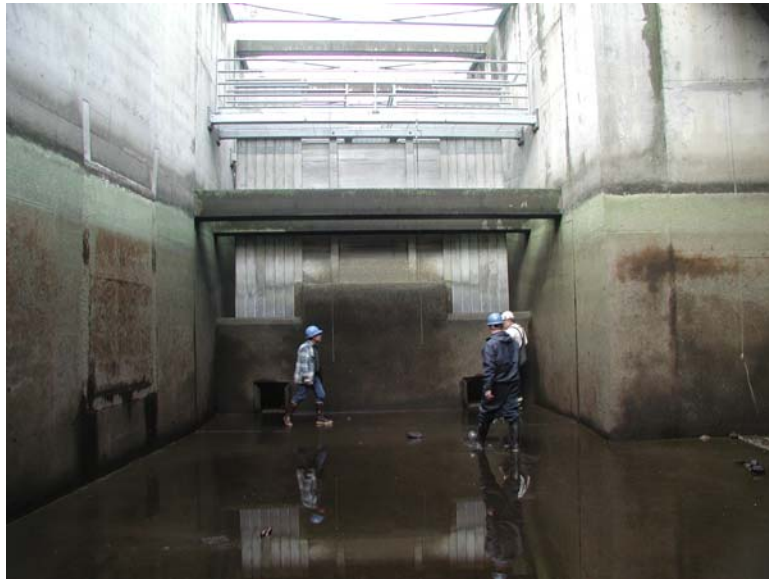
Figure 7b. These two pictures show the poorly lighted area that should lead adult fish from the North shore fishway to this channel that connects to the North powerhouse channel. These lights do not appear to have good passage conditions for fish that enter the North shore and then pass through this lighted tunnel/channel to the North powerhouse area. The same condition would be in service at Little Goose Dam.

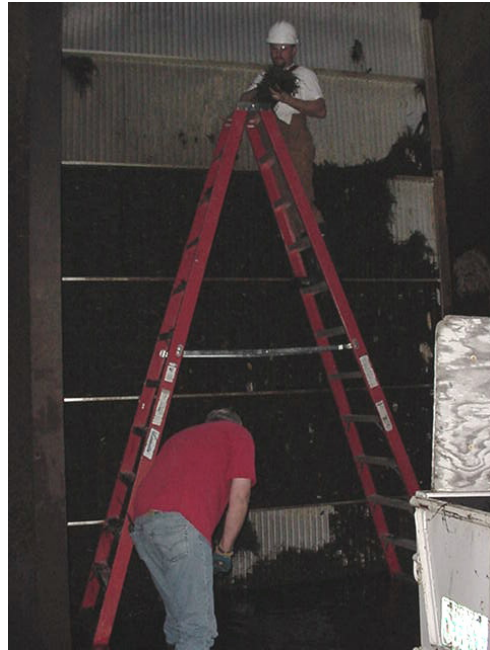
- As in previous seasons, large quantities of floating aquatic grasses such as milfoil, elodea, etc., were present in the upper and lower Columbia Rivers, and these grasses caused problems with trashracks, diffuser gratings, and other equipment at the dams. Most projects were affected to some degree by the influx of these grasses at the fish facilities. The heaviest grass problems occur mainly at the upper three Columbia River dams. This may require a fishway be taken out of service for a portion of a day while the grasses are removed from the trash racks or from the wall screens at the various projects (See photos from Rock Island Dam).

Figure 10b. Rock Island personnel cleaning the heavy grass load from the AWS screens in September 2005.

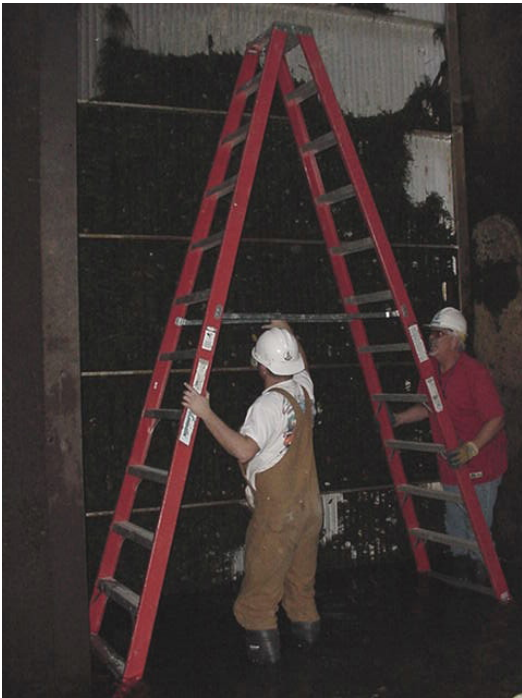
Figure 10c. Rock Island personnel cleaning AWS screens in September 2005.

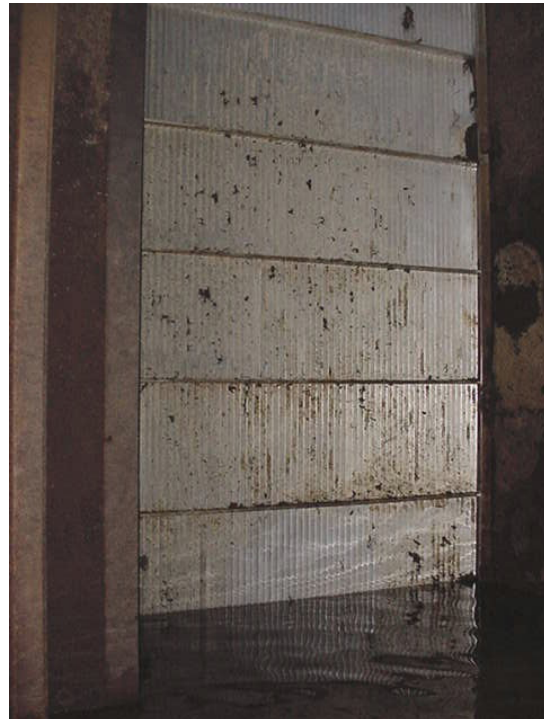
Figure 10d. AWS screen cleaning took about 6 hours (including dewatering the ladder and removing the adult fish from the upper pool). The fish ladder was immediately watered up and fish passage continued.

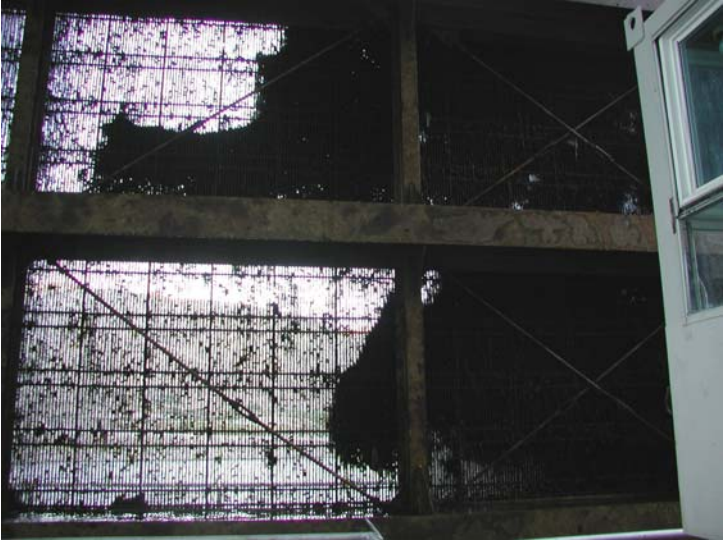
Figure 11a. Photograph depicts pump intake screens with amounts of grasses, resulting in shutdown of the fish pumps until the screens were cleaned.

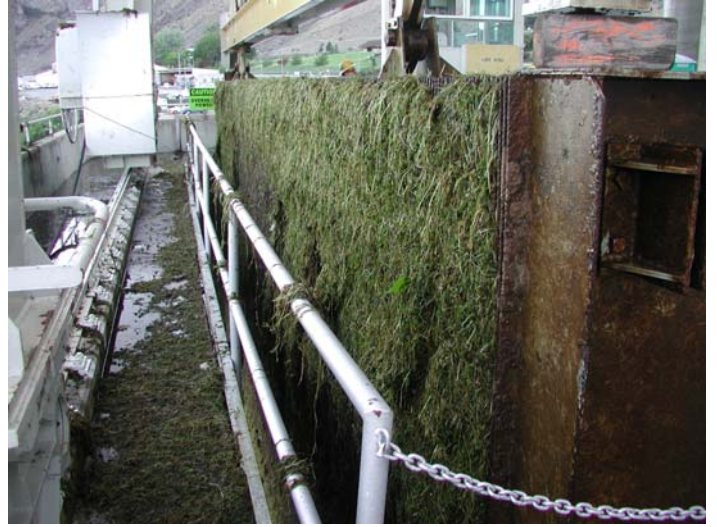
Figure 11b. Top edge of screen that was pulled from the intake valve.

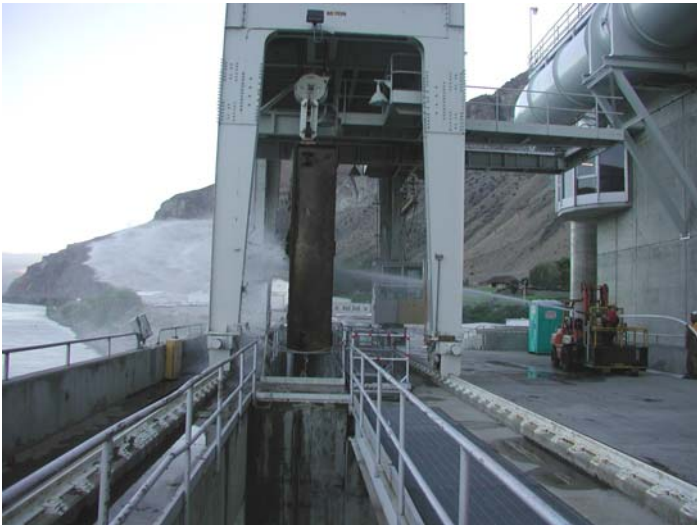
Figure 11c. Crane holds screen in place while project personnel hose grasses from screen.

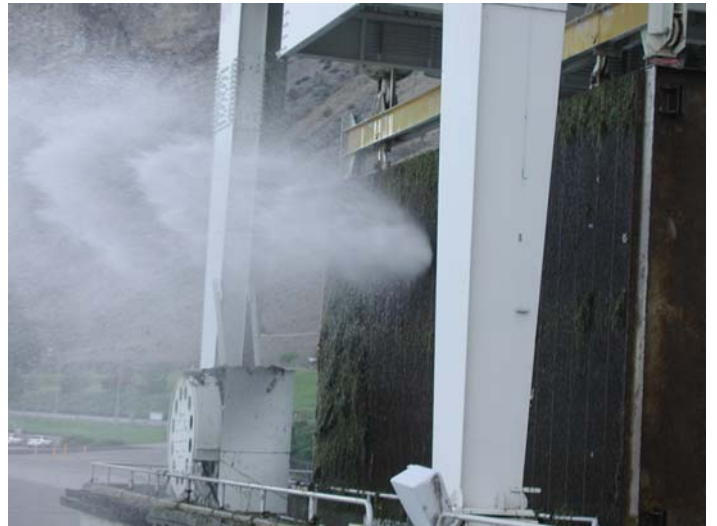
Figure 11d. Large mats of grasses are hosed from the screens during late summer cleaning of the intake valves a Rocky Reach Dam.
