**ADULT FISHWAY INSPECTIONS
ON THE COLUMBIA AND SNAKE RIVERS**

2005 ANNUAL REPORT

**FISH PASSAGE CENTER
1827 NE 44th Ave.
Portland, OR 97213**

March 2006

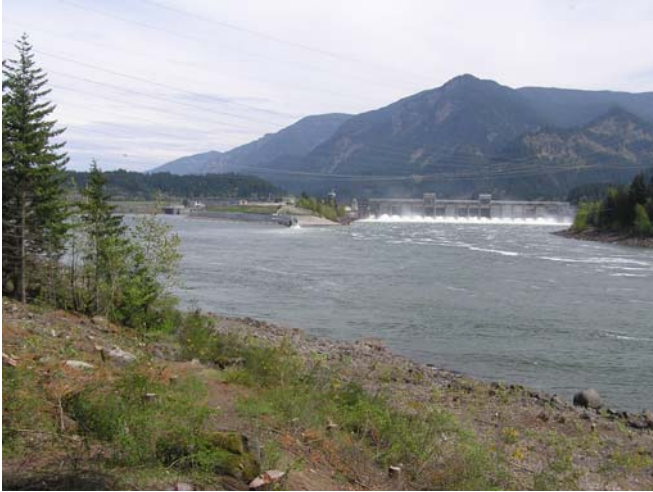
Figure 1a. Bonneville Dam looking upstream into junction to spillway and into junction leading to the New Powerhouse.

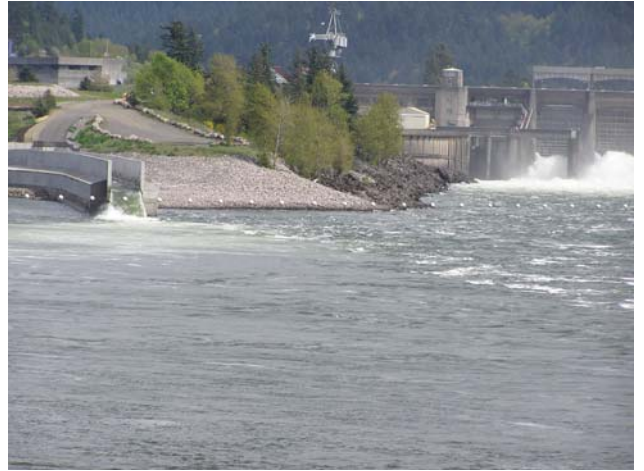
Figure 1b. Bonneville Dam looking upstream to new juvenile bypass outfall from the Corner Collector at New powerhouse and upstream to the the Cascades Island adult fishway entrance located at the north end of the spillbasin.

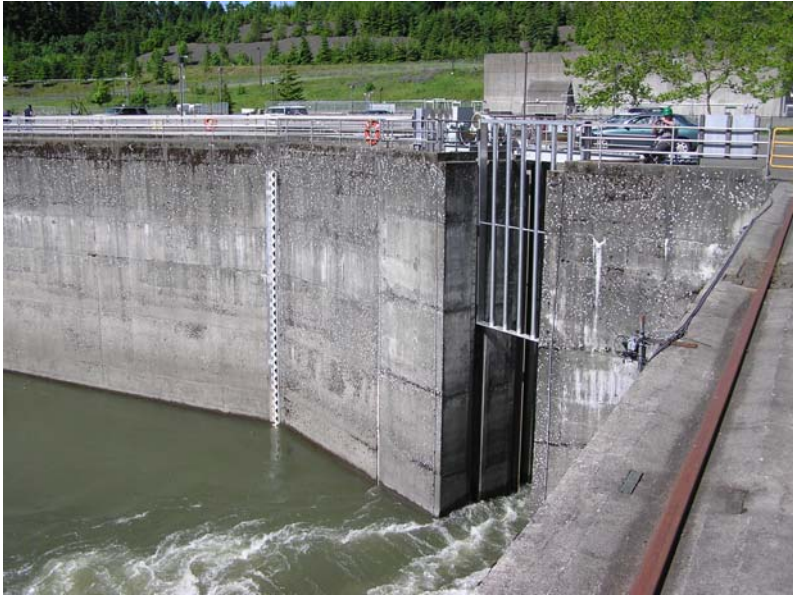
Figure 3a. Sea lion excluders are placed in the new powerhouse entrance gates in mid to late May to keep these mammals outside the actual fishways.

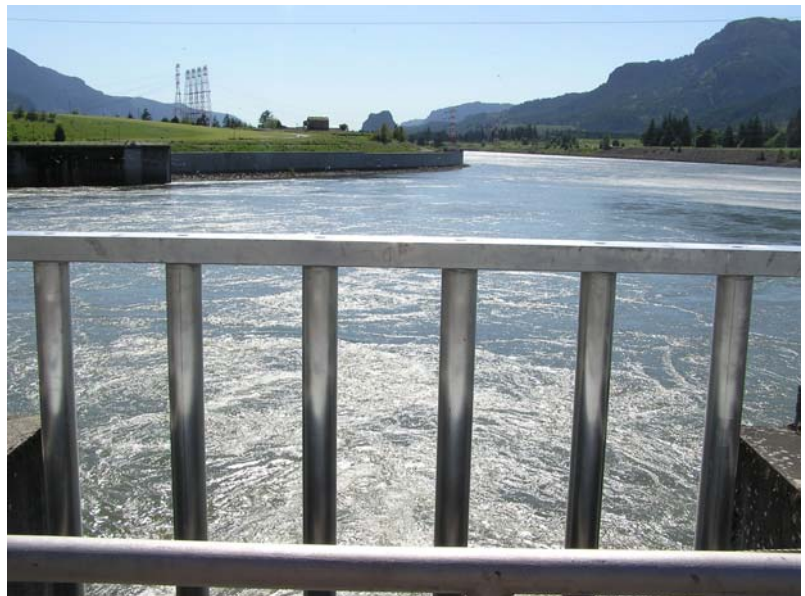
Figure 3b. The large excluder gate is placed in the downstream gate slot with individual partitions

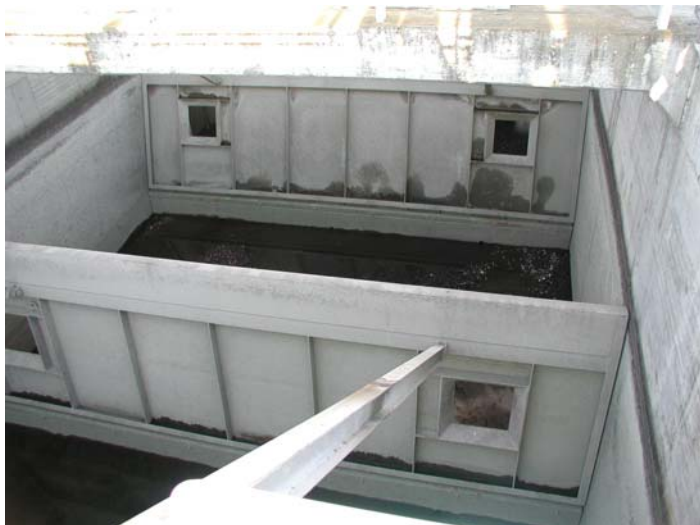
Figure 4a. Tilting weirs at exit from OR shore fish ladder when dewatered for winter maintenance 2003.

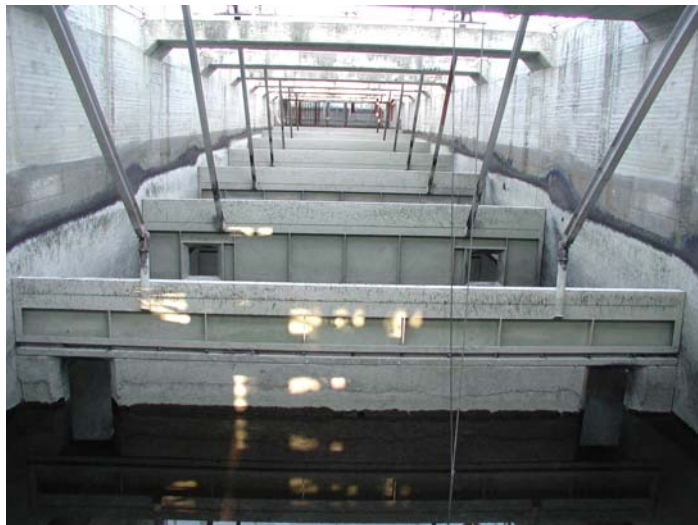
Figure 4b. Tilting weir gates during the winter maintenance period when ladder was being dewatered in 2003.

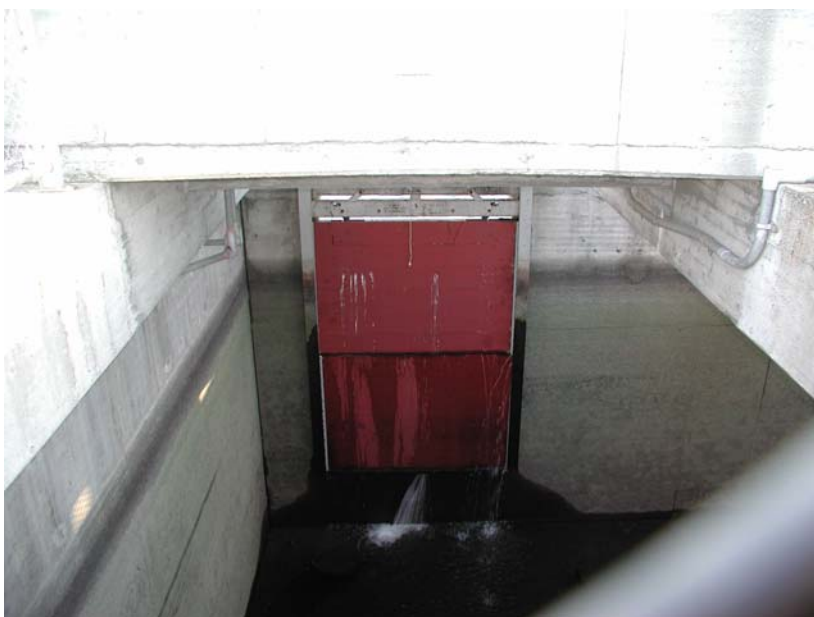
Figure 4c. Red gate is the adult fish exit from the fish ladder. This photograph was taken during the winter maintenance period when the ladder was dewatered in 2003.

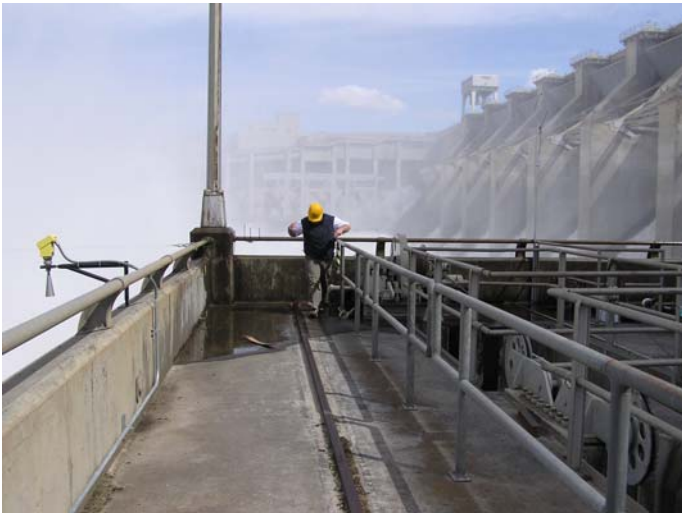
Figure 5a. Steve Richards, WDFW, takes reading at NPE under misty conditions from spill basin.

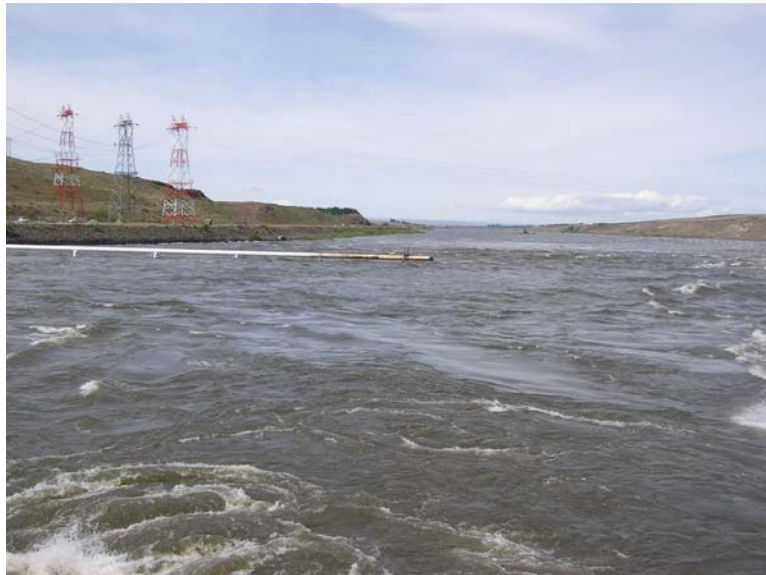
Figure 5c. Note the location of the juvenile bypass outfall pipe looking downstream from the powerhouse deck (unit 6) at Ice Harbor Dam. Photo taken May 05.

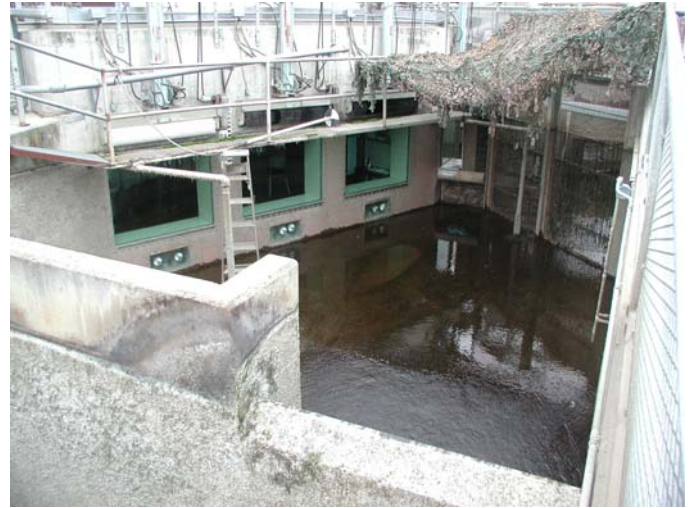
Figure 6b. The adult fish counting station is located upstream from Figure 6a. Note the camouflage netting which is used to cut down the direct sunlight into the fish counting slot.

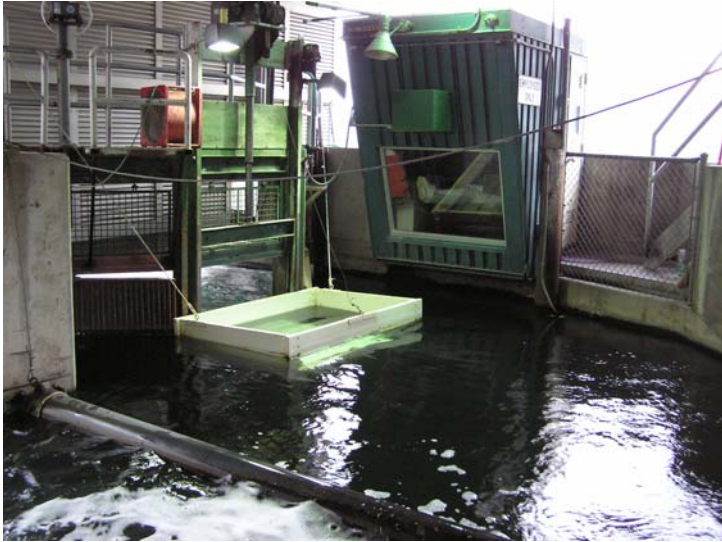
Figure 8a. Old Right Bank fish counting station and last fish counting board on the Columbia River; removed from this Location in mid July 2005.

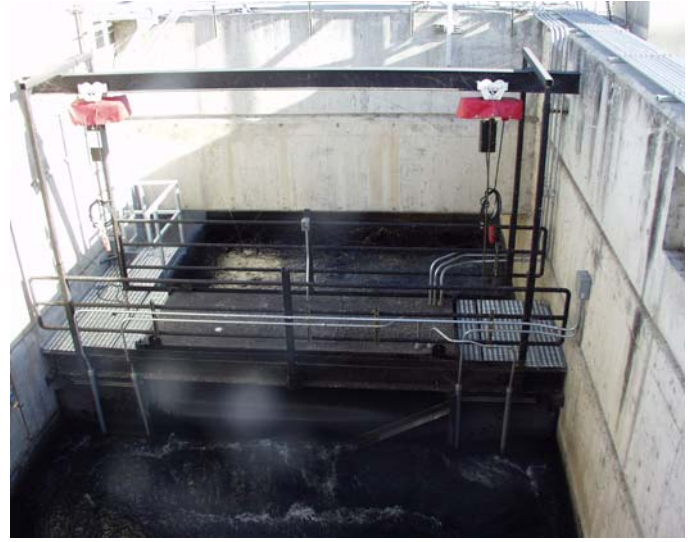
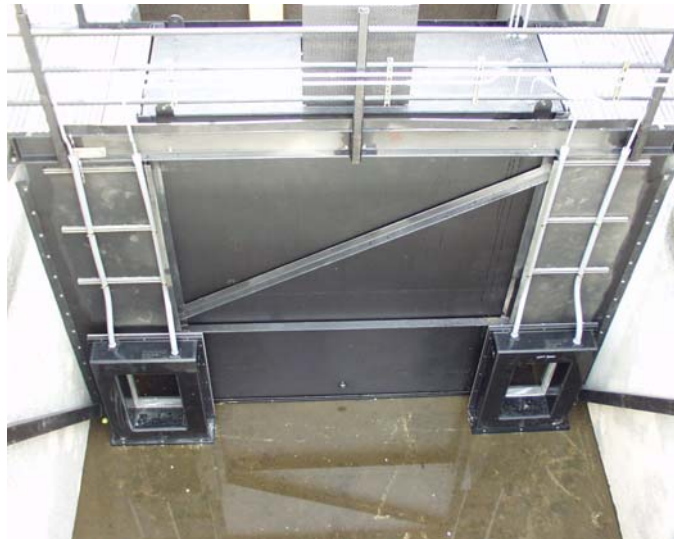
Figures a-c. The Wanapum and Priest Rapids new count stations are now located in the exit section of the Right and Left fish ladders. Cameras are enclosed in the caisson and record adult fish as they swim through the orifices of the slot and as noted have the PIT tag diction system on the upstream end of the counting area.

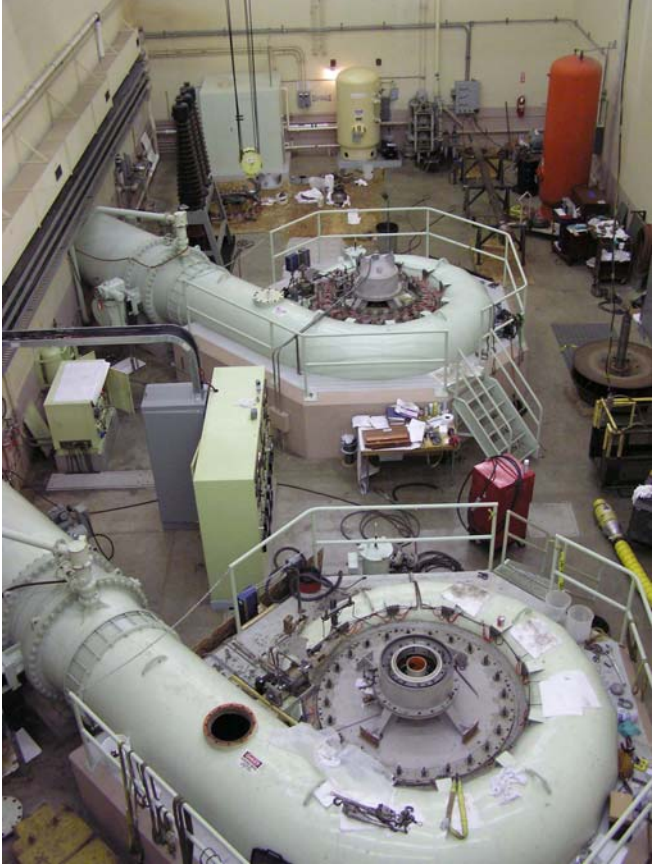
Figure 9a. Two turbine driven fish pumps that supply Attraction flows to the Left Bank adult fishway at Wanapum Dam. Pump 1 was overhauled during the 2005 winter maintenance period

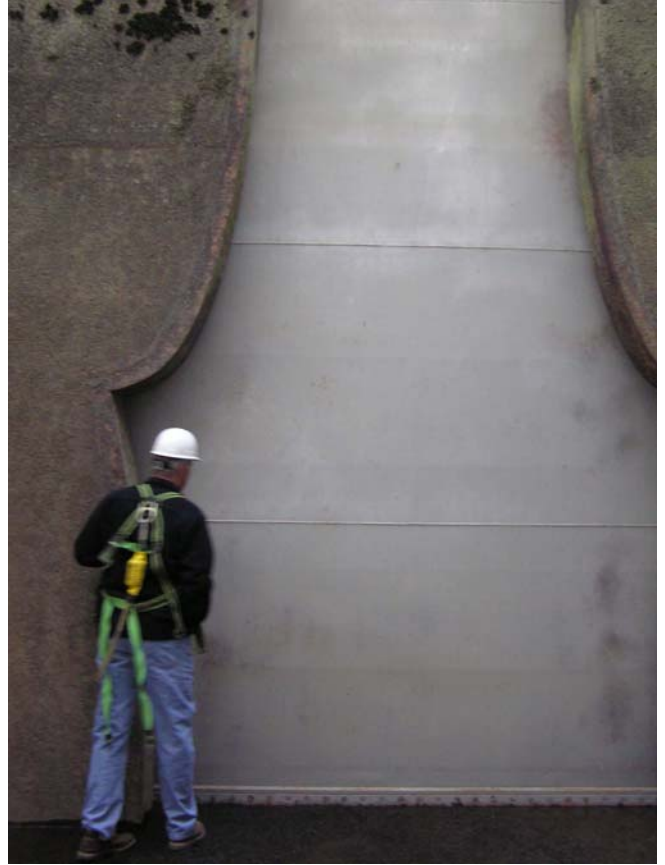
Figure 9b. Eric Lauver, Grant PUD biologist, standing next to the large elliptical end gate at Wanapum Dam during the past winter maintenance period.

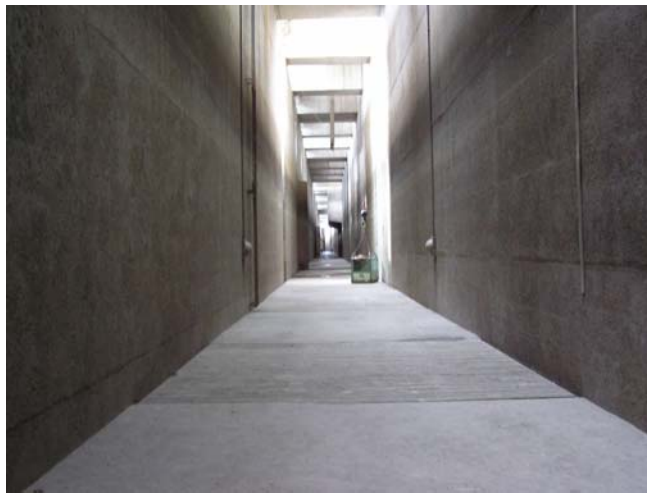
Figure 9c. The length of the collection channel spans the Powerhouse at the project. There are two main entrance gates to attract and pass adult fish at the Left Bank fishway.

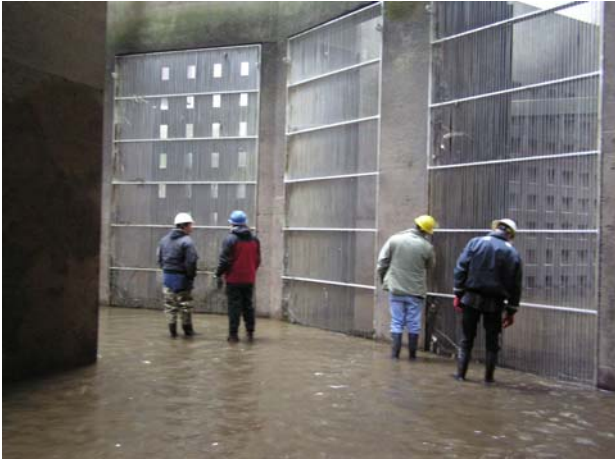
Figure 10a. Photograph taken during 2005 winter Maintenance season showing clean AWSs at the Right Bank fishway at Rock Island new powerhouse.

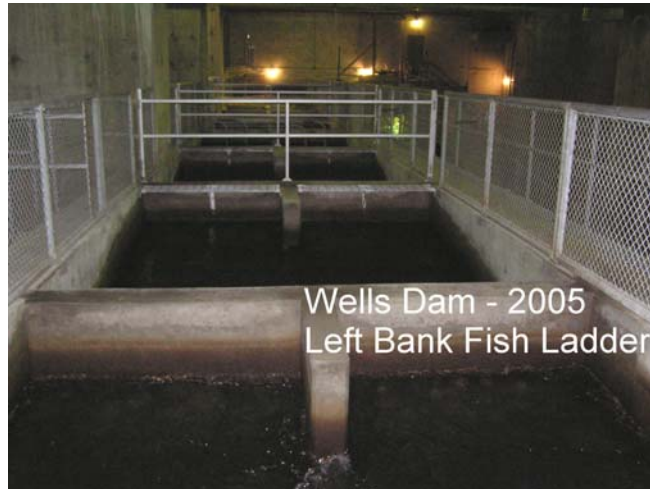
Figure 12a. Both fish ladders at Wells Dam are enclosed; i.e., the fish ladder has a roof over it and uses artificial lighting. Wells is the only fish ladder that is enclosed on the Columbia or Snake River.

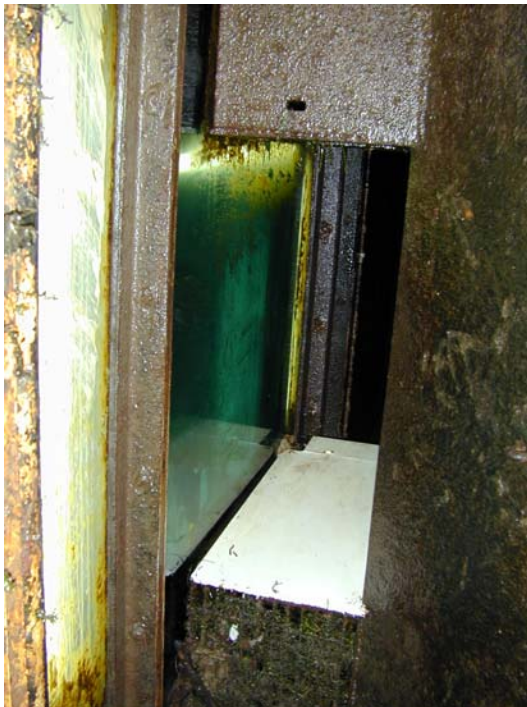
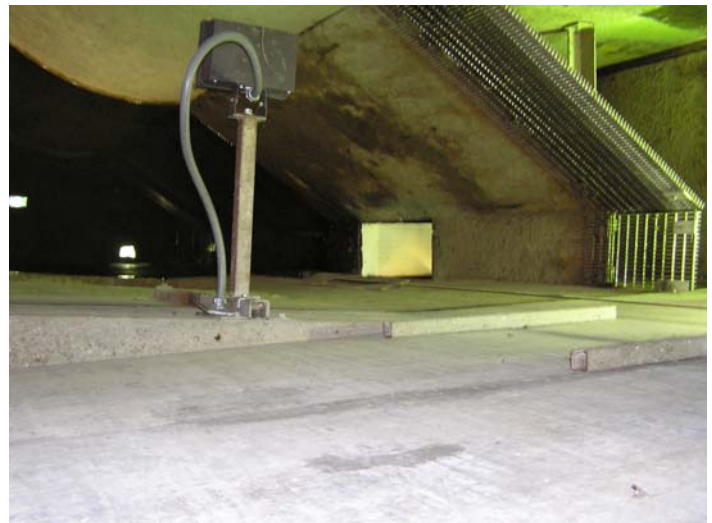
Figures 12b and 12c. Photographs of the fish count windows (similar on each ladder) during the winter maintenance period when the fish ladder was dewatered. The count windows are fairly narrow and are ramped up or down at each end of the count window with a downstream lead to guide the fish to the counting window.
